One More Thing About That

by Steve Grimm,
Wastewater Technician

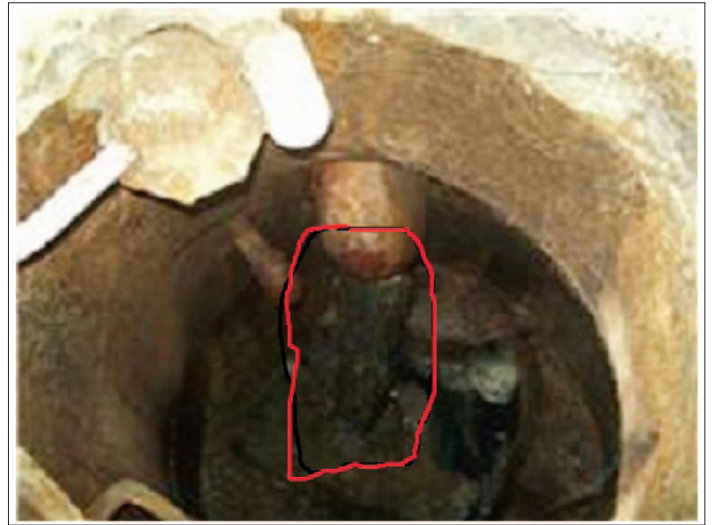
This is the first time I've attempted to include pictures in my article. I'm no photographer, so please bear with me. Does anyone know what the outlined "thing" is? Oh, I should tell you this is a picture of a manhole. So, guesses anyone? I won't make you suffer and read the entire article. That is a ROOT! OK, now you can turn the page. For those of you that are still here, that is a root growing in a lateral that discharges directly into the manhole. You need a chainsaw to cut this root. Jack wished his bean stalk was this big. That root goes at least 10 feet down to the bottom of the manhole, and then, as any good root would do, looks for places it can continue to grow and flourish. Breaking the manhole bottom, snaking down another line. Get the picture?
